FORECASTING AND ASSESSING EUROPE'S  
STRATEGIC RAW MATERIALS NEEDS

## WP7 Historic Mine Sites revisited

### *Deposit Fact Sheet*

## Storwartz Ore Field

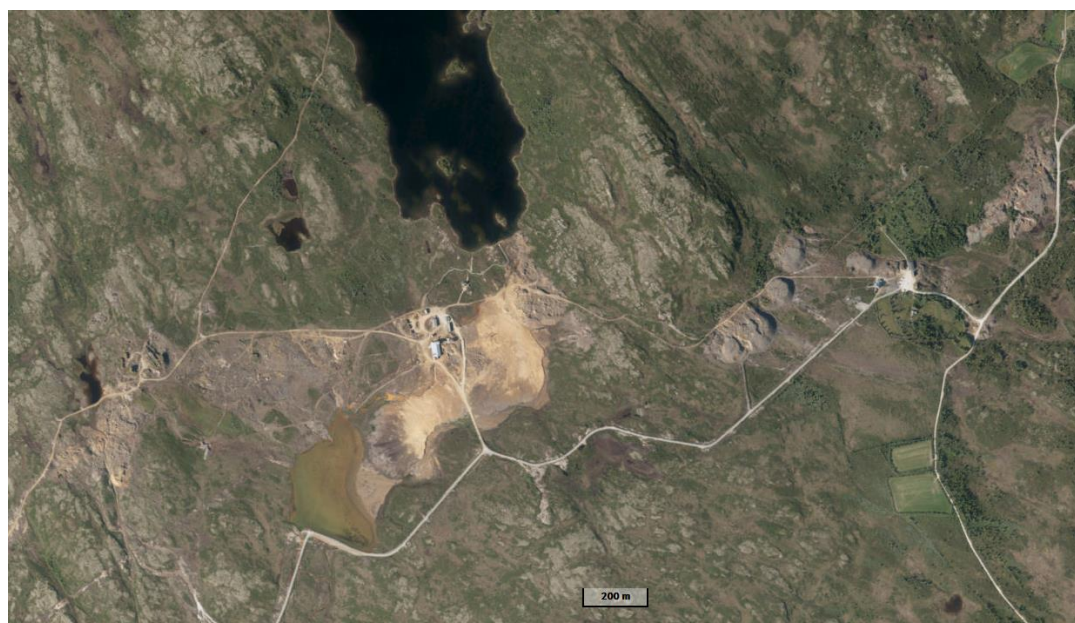
Aerial photo of the Storwartz ore field with waste dumps.
